REFURBISHMENT SIKA TECHNOLOGIES AND SOLUTIONS FOR WASTE WATER TREATMENT PLANTS

SIKA – YOUR PARTNER

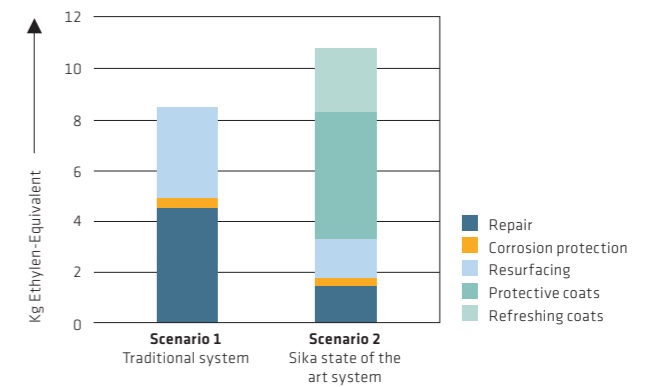
Photochemical Ozone Creation Potential (POCP)

Scenario 2 has a higher POCP impact due to the use of epoxy coating. However, the impact to the environment is minimal. The difference between the two scenarios over the life cycle period (60 years) is only 2.5 Kg of Ethylen equivalent. This represents only 40 g per year (~1 bottle of nail polish remover per year).

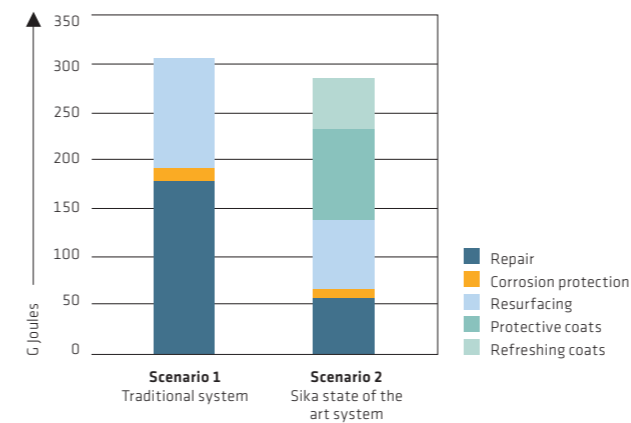
Cumulative Energy Demand (CED)

Even when using epoxy based materials to increase durability, scenario 2 has a slightly lower CED than scenario 1 due to its greater resource efficiency (lower material consumption over the whole life cycle). This is an equivalent saving of 550 liters of oil over the life cycle period (60 years).

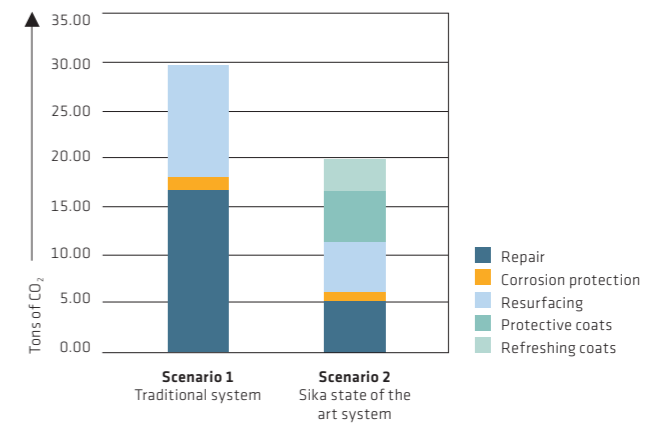
Global Warming Potential

The greater resource efficiency of scenario 2 allows savings of 10 tons of CO₂ over the life cycle period (60 years). Comparing this value to the limit of the European Union strategy adopted in 2007 (not more than 130 g of CO₂ per km in 2015), this saving is equivalent to a car's CO₂ emission during ~1'300 km per year.

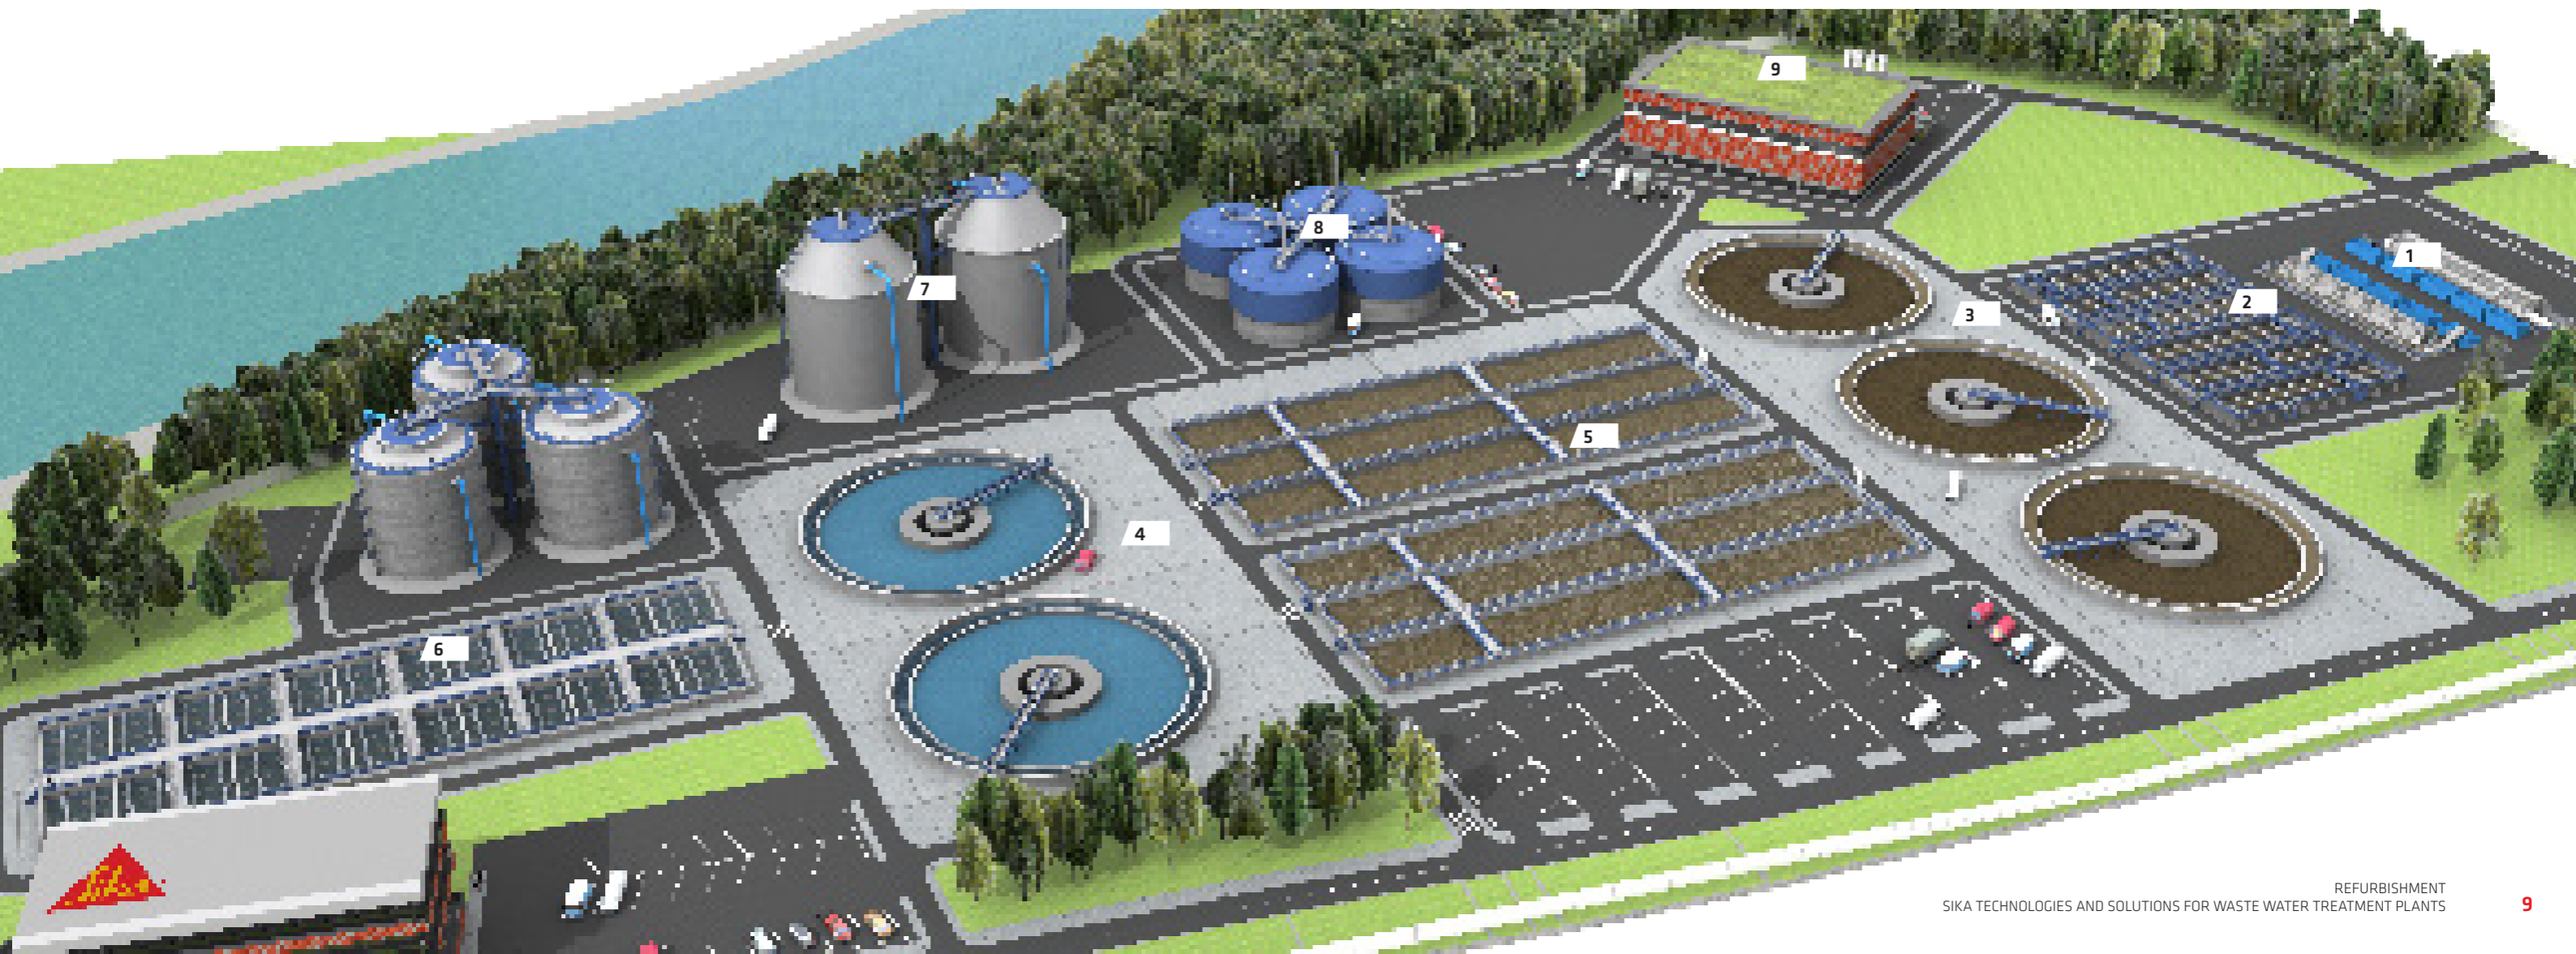
Most accessible sewers are more than 50 years old and in most cases are made of tamped or reinforced concrete in round, rectangular or ovoid shapes. Generally, sewers present three different zones of stresses with specific issues:

- A: Biogenic aggression, runoff, storm water, waste water or condensation
- B: Runoff, storm and waste water, erosion and corrosion defects
- C: Waste water, erosion and abrasion

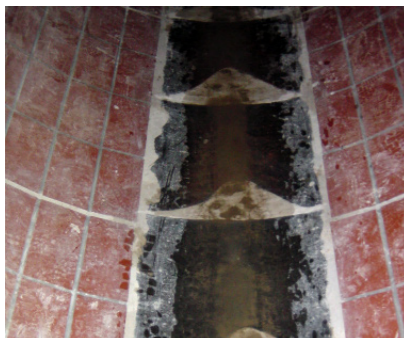
1 Damages at the bottom:

Heavy abrasion and erosion of the concrete and prefabricated elements are often found at the bottom of the sewers. In general rules, these elements shall be replaced and reassembled properly by bonding them in place with an epoxy adhesive.

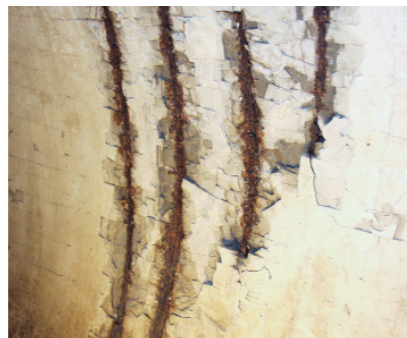
2 Localized defects of the concrete:

Lateral walls and the crown often show localized defects of the concrete and sometimes defects due to the corrosion of the reinforcement. After appropriate preparation, these defects can be repaired using sulfate resistant repair mortars.

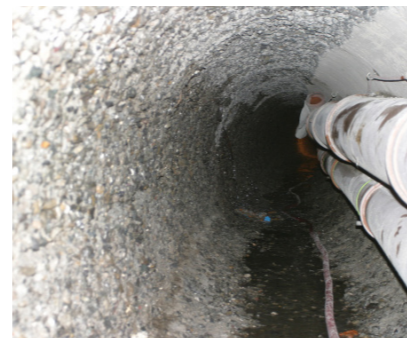
3 Full degradation of the concrete surface:

The resistance of tamped concrete against a strong water current is generally not enough and often the full surface of the concrete is eroded. It is recommended in these zones to proceed with a full resurfacing.

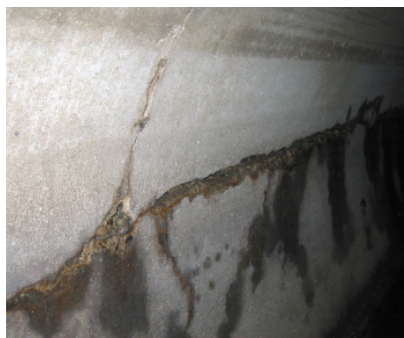
4 Cracks with water leaks:

Due to shrinkage or settlements, concrete in sewers often cracks. These cracks need to be filled in order to prevent leakage of pollutant to surrounding ground water. It is often necessary to use expanding materials to fill these cracks.

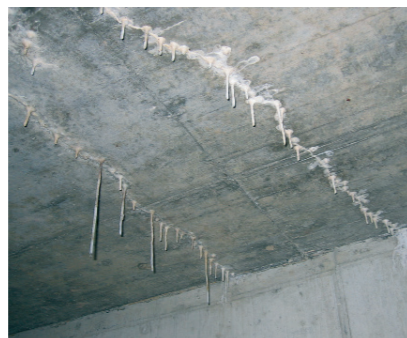
5 Damages at the crown:

Exposed tamped concrete surfaces show very low resistance against carbonation and the aggressive substances contained in the waste water. Therefore, these surfaces can be protected using EpoCem® technologies which are extremely resis-

tant and watertight against urban waste water. At the crown area, the structure can be protected against condensation water using a hydrophobic impregnation.

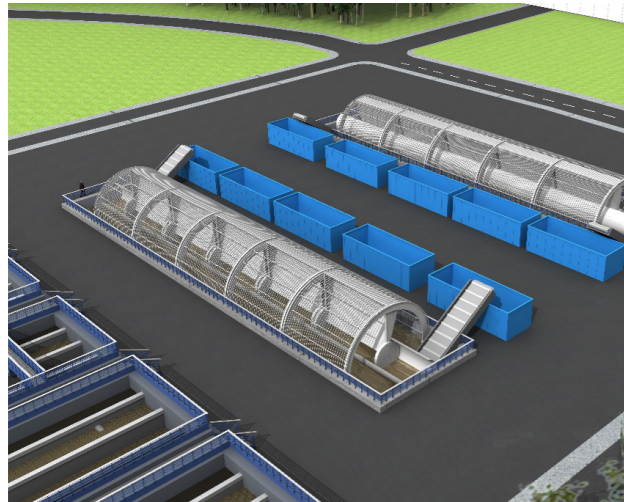
SCREENING CHANNELS

- Abrasion and erosion due to sand, grit or other heavy particles
- Chemical attacks due to aggressive waste or industrial water
- Leakage due to cracks, untight joints or damaged concrete

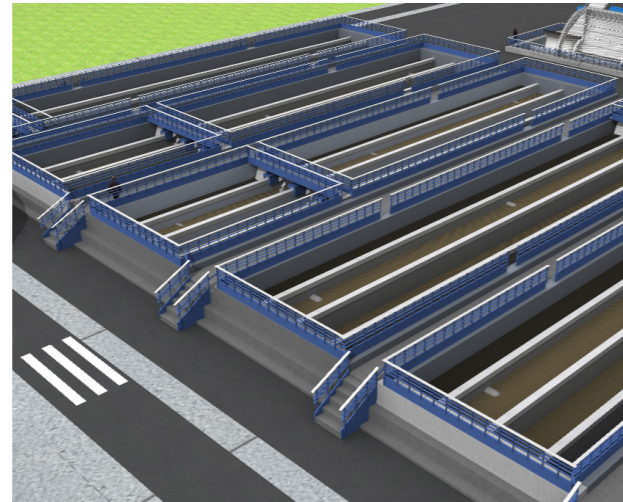
GRIT, FAT & GREASE CHAMBERS

- Abrasion and erosion due to sand, grit or other heavy particles
- Chemical attacks due to aggressive waste or industrial water
- Leakage due to cracks, untight joints or damaged concrete

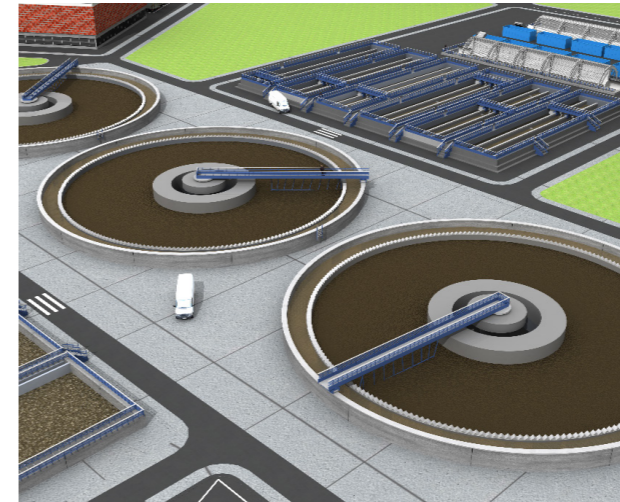
PRIMARY SEDIMENTATION TANKS

- Chemical attacks due to aggressive waste or industrial water
- Leakage due to improper waterproofing
- Cracks due to thermal expansion or shrinkage
- Steel reinforcement corrosion due to low concrete cover
- Mechanical abrasion at the rolling pad

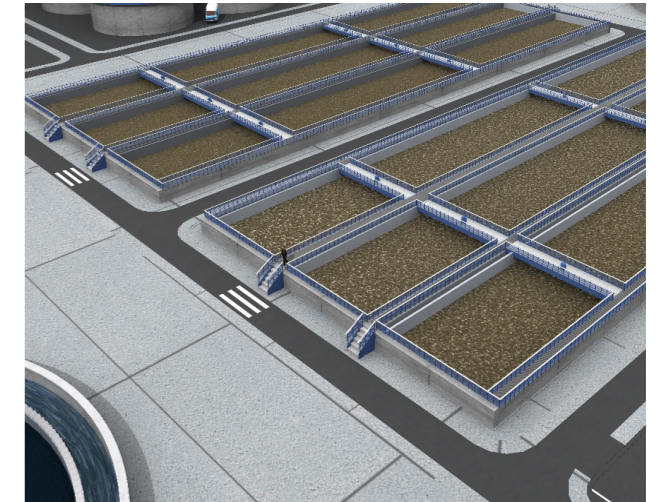
BIOLOGICAL TANKS

- Erosion due to water flow
- Chemical attacks due to aggressive waste or industrial water
- Leakage due to damaged waterproofing
- Cracks due to thermal expansion or shrinkage
- Steel reinforcement corrosion due to low concrete cover

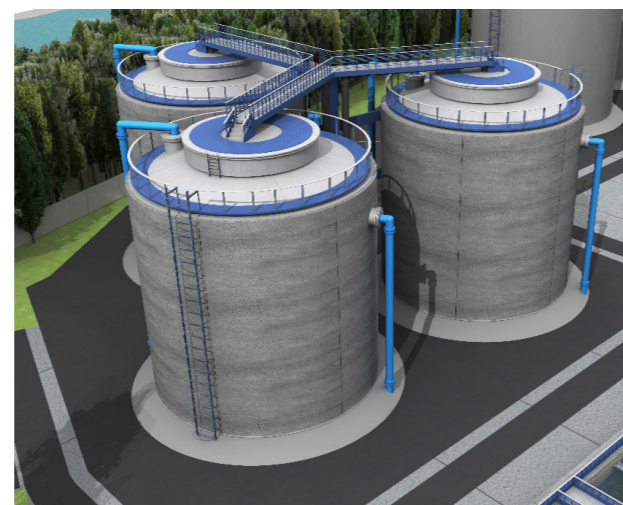
DIGESTION TANKS

- Concrete damage due to sulfuric acid
- Leakage due to damaged waterproofing
- Cracks due to thermal expansion or shrinkage

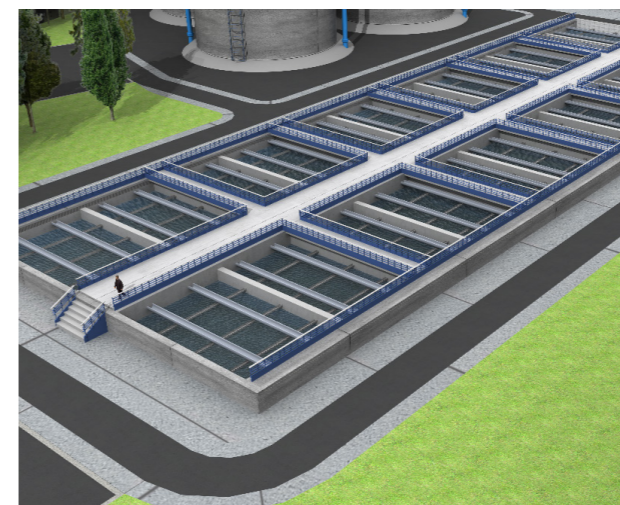
FILTRATION BEDS

- Abrasion due to sand
- Leakage due to damaged waterproofing
- Cracks due to thermal expansion or shrinkage

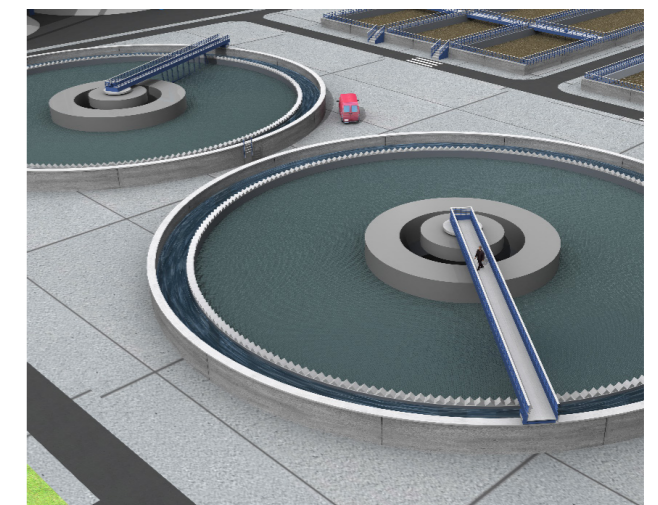
SECONDARY SEDIMENTATION TANKS

- Leakage due to damaged waterproofing
- Cracks due to thermal expansion or shrinkage
- Mechanical abrasion at the rolling pad

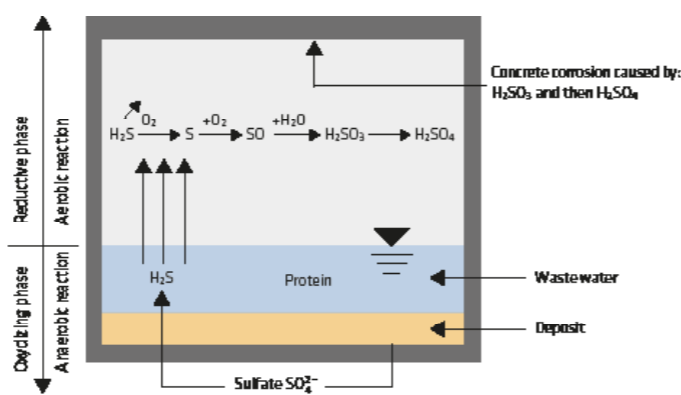
Danger in delay – Biogenic Sulfuric Acid corrosion (BSA)

The chemical composition of biogas consists mainly of methane and variable concentrations of carbon dioxide, water vapour, hydrogen sulfide, nitrogen, oxygen and hydrogen. The proteins present in the fermenters break down into amino acids. These amino acids and the sulfates present form, among other things, hydrogen sulfide (H₂S). This moves to the gas compartment by diffusion, where it is oxidized and condenses on the walls and soffits as elementary sulfur deposits. The sulfur is then used as an energy source by thiobacteria and is thereby converted primarily to sulfurous (H₂SO₃) and then to sulfuric acid (H₂SO₄). This “biogenically” formed sulfuric acid aggressively corrodes metal components and severely attacks concrete, destroying it progressively from the inside.

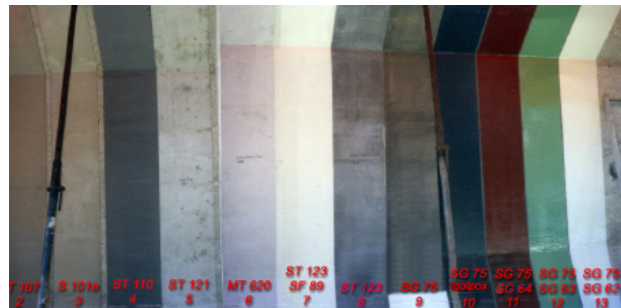
View of the various systems right after application in September 1991

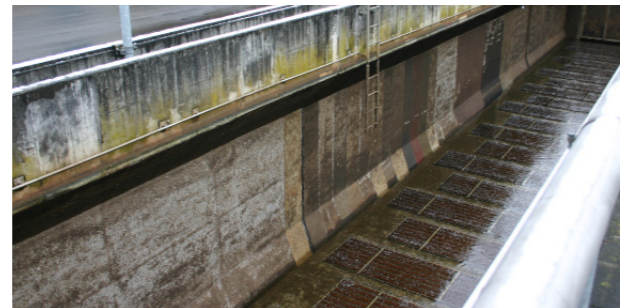
Overview of the test areas in 2008

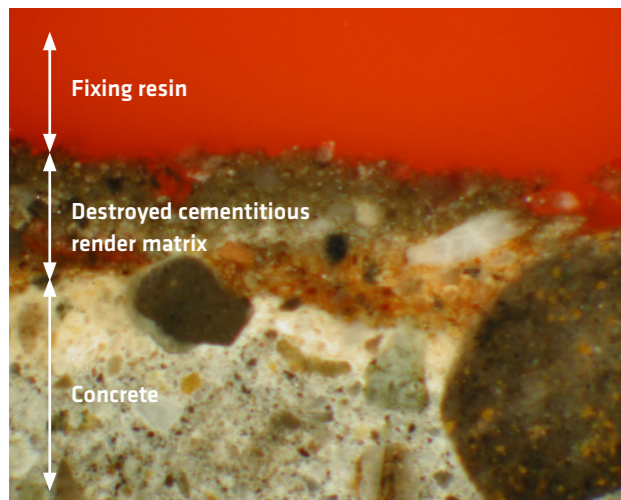
Cementitious mortars:

Because the sewage dissolves the cement paste, continuous erosion begins within a short period of time. The binder matrix is weakened and the aggregates then break away.

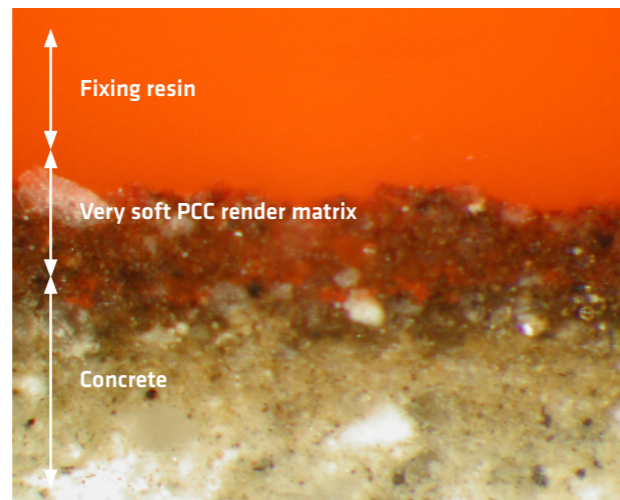
Polymer modified cementitious mortars:

They have a longer durability than normal cementitious mortars. However, when subject to aggressive chemical environments, their resistance is significantly reduced. When not over-coated, they can only provide protection for a short term.

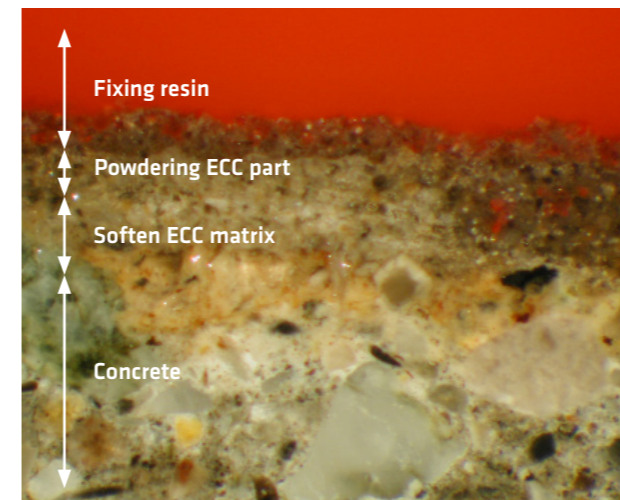
Epoxy cement mortar:

The epoxy resin component improves the chemical resistance of the cement matrix. But due to the level of aggressiveness in waste treatment plant, they can only provide protection for a medium term.

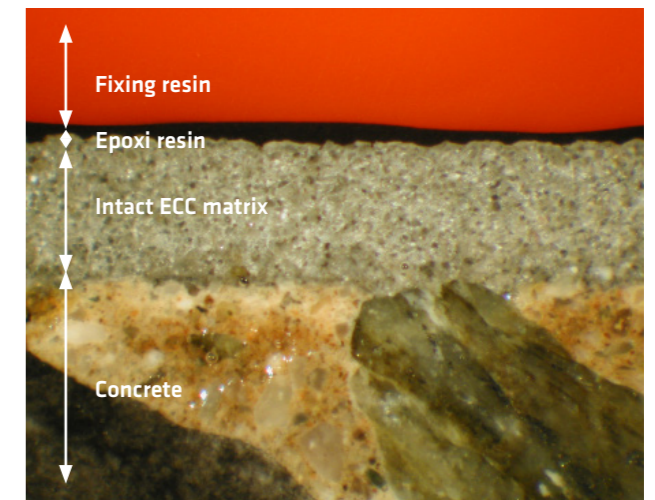
Resin coatings:

According to their formulations, resin coatings (epoxy or polyurea) can bring long-term durability. However, particular attention must be paid to prevent osmotic blister by the use of EpoCem® levelling mortar as pre-treatment. Sikagard®-720 EpoCem® does not require curing and allows for a fast over-coating with a reactive resin. This allows a quicker and safer application process than normal cement render.

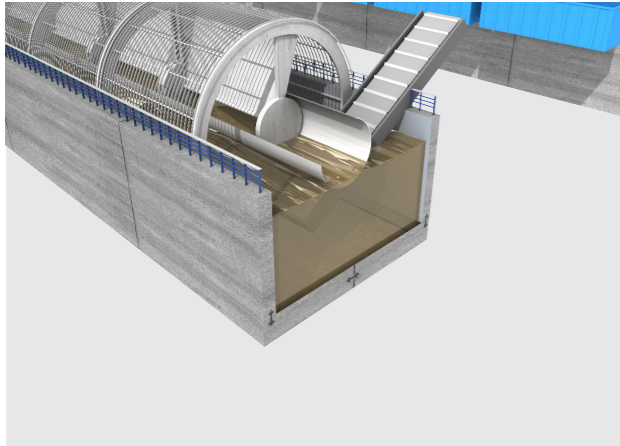
SCREENING CHANNELS

- Abrasion and erosion:
Sika® Abraroc® SR
- Chemical attacks:
Sikagard®-720 EpoCem® + Sika® Poxitar F (or Sikagard®-63 N)
- Cracks, untight joints:
Sikadur-Combiflex® SG or Sikaflex® Pro-3

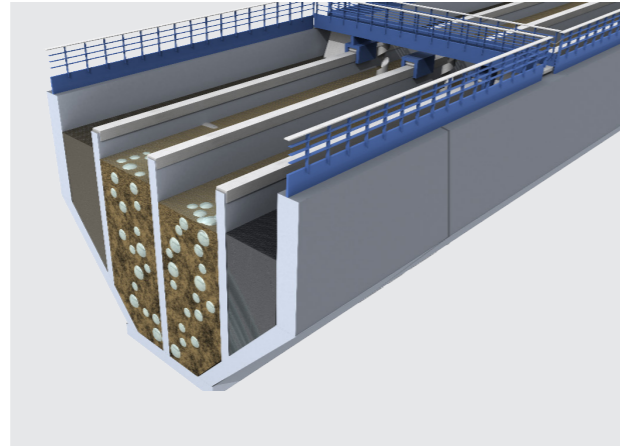
GRIT, FAT & GREASE CHAMBERS

- Abrasion and erosion:
Sika® Abraroc® SR
- Chemical attacks:
Sikagard®-720 EpoCem® + Sika® Poxitar F (or Sikagard®-63 N)
- Cracks, untight joints:
Sikadur-Combiflex® SG or Sikaflex® Pro-3

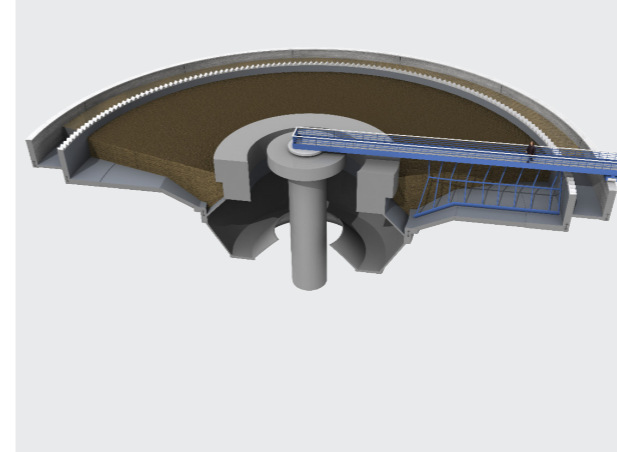
PRIMARY SEDIMENTATION TANKS

- Chemical attacks and damaged waterproofing:
Sikagard®-720 EpoCem® + Sika® Poxitar F (or Sikagard®-63 N)
- Cracks, untight joints:
Sikadur-Combiflex® SG or Sikaflex® Pro-3
- Damaged concrete and steel reinforcement corrosion:
Sika MonoTop®-412 NFG, SikaTop® Armatec®-110 EpoCem®
- Mechanical abrasion:
Sikadur®-42 or Sika® Icosit®-KC 330 FK

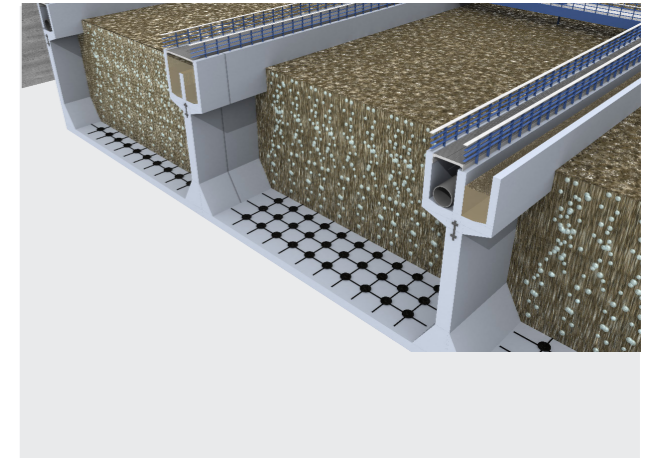
BIOLOGICAL TANKS

- Chemical attacks and damaged waterproofing:
Sikagard®-720 EpoCem® + Sika® Poxitar F (or Sikagard®-63 N)
- Cracks, untight joints:
Sikadur-Combiflex® SG or Sikaflex® Pro-3
- Damaged concrete and steel reinforcement corrosion:
Sika MonoTop®-412 NFG, SikaTop® Armatec®-110 EpoCem®

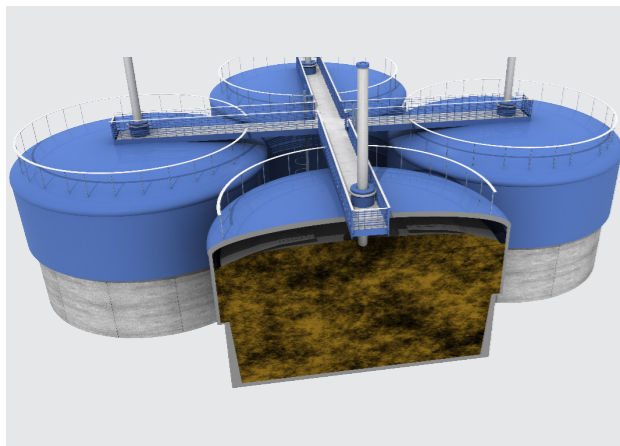
GASOMETERS

- Steel corrosion:
Sika® Icosit® 6630 System or SikaCor® EG System
- Steel joint:
Sikaflex® TS Plus
- Sulfuric acid attack:
Sika® Permacor® 3326 EG H or Sikalastic®-844 XT

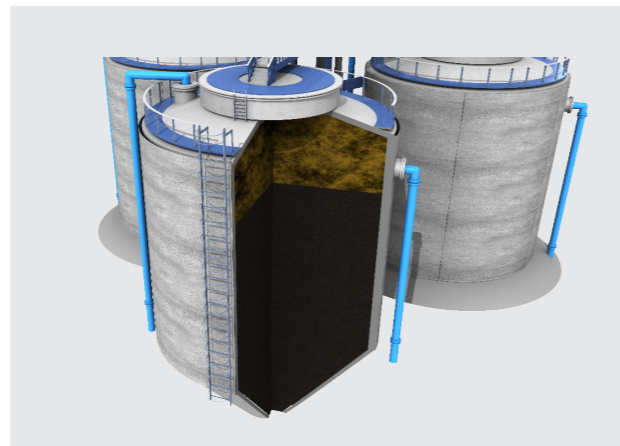
DIGESTION TANKS

- Sulfuric acid attack and waterproofing:
Sika® Permacor® 3326 EG H or Sikalastic®-844 XT
- Cracks:
Sikadur-Combiflex® SG
- Chemical resistant joint:
Sikaflex® Pro-3

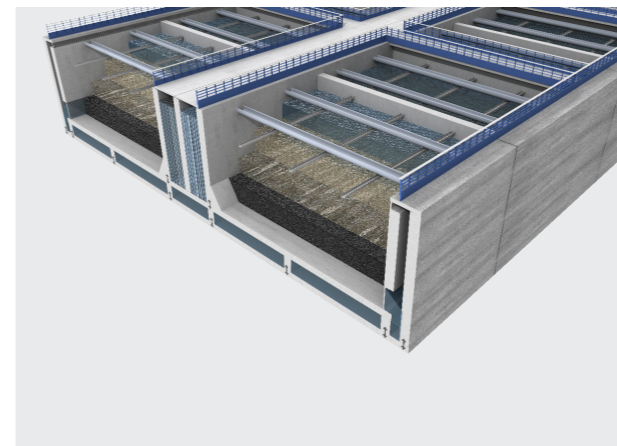
FILTRATION BEDS

- Abrasion:
Sika® Abraroc® SR
- Damaged waterproofing:
Sikagard®-720 EpoCem®
- Cracks:
Sikadur-Combiflex® SG or Sikaflex® Pro-3

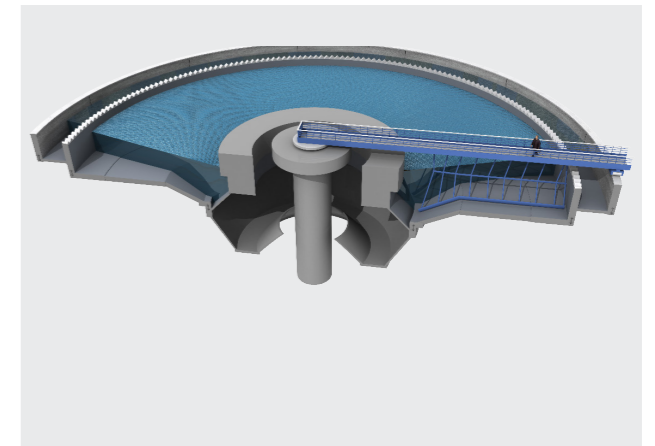
SECONDARY SEDIMENTATION TANKS

- Damaged waterproofing:
Sikagard®-720 EpoCem®
- Cracks:
Sikadur-Combiflex® SG or Sikaflex® Pro-3

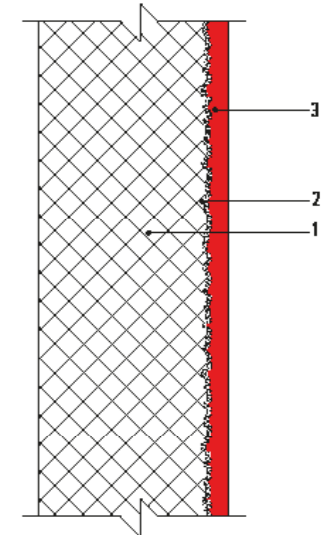
TYPICAL DETAIL

- 1 Host concrete
- 2 Abraded surface
- 3 Over laying with Sika® Abraroc® SR

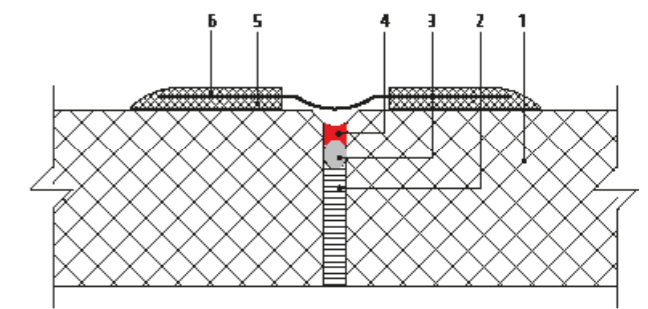
TYPICAL DETAIL

- | | |

| 1 Substrate | 4 Failed sealant |

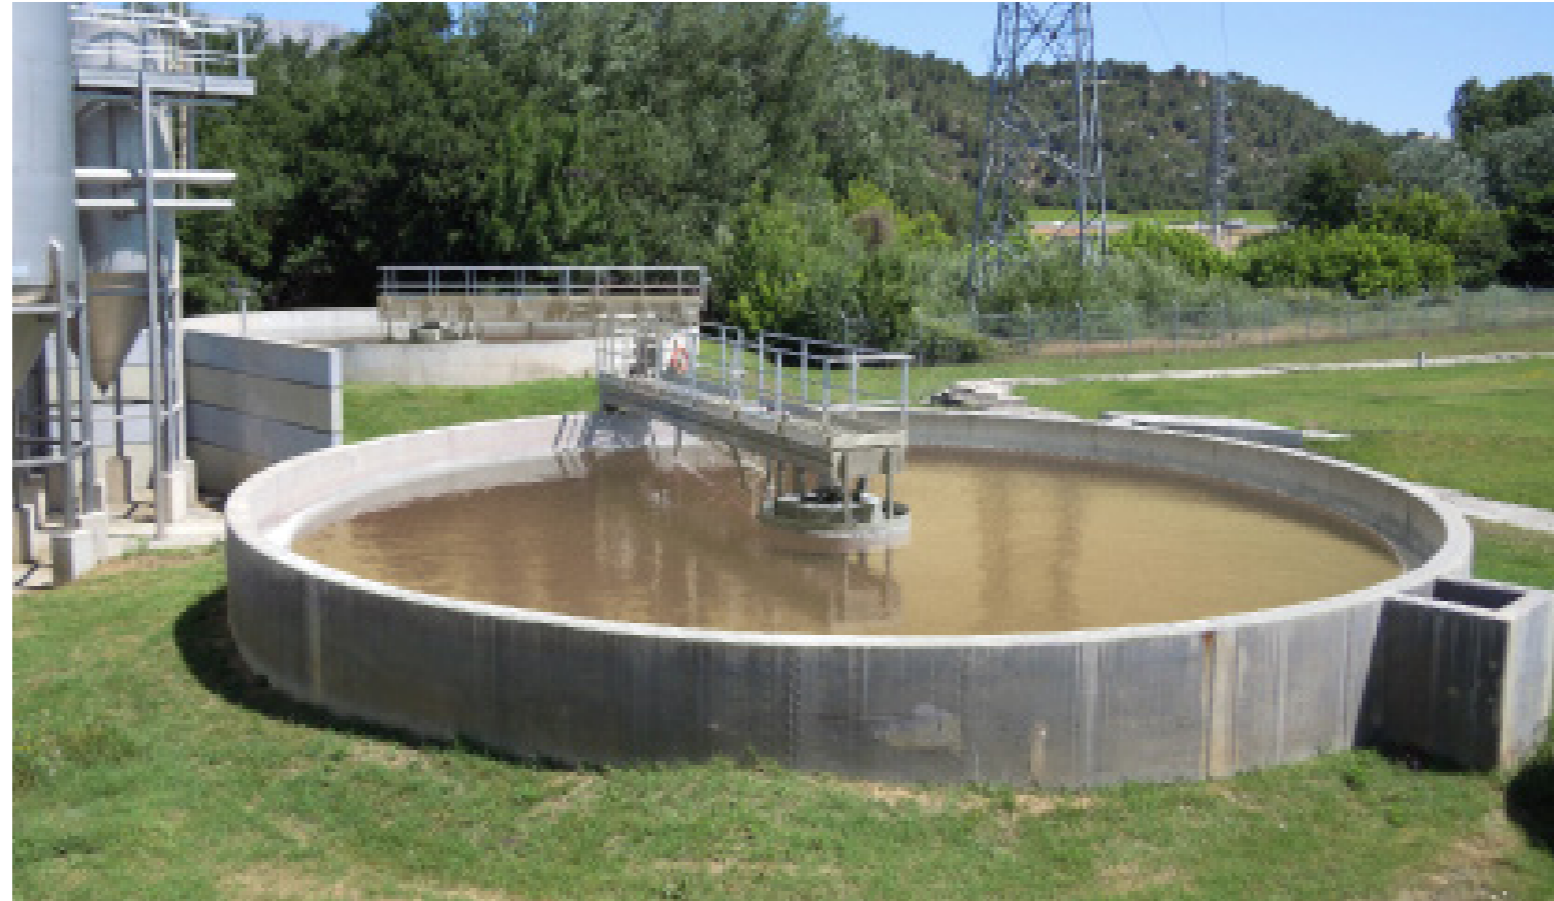
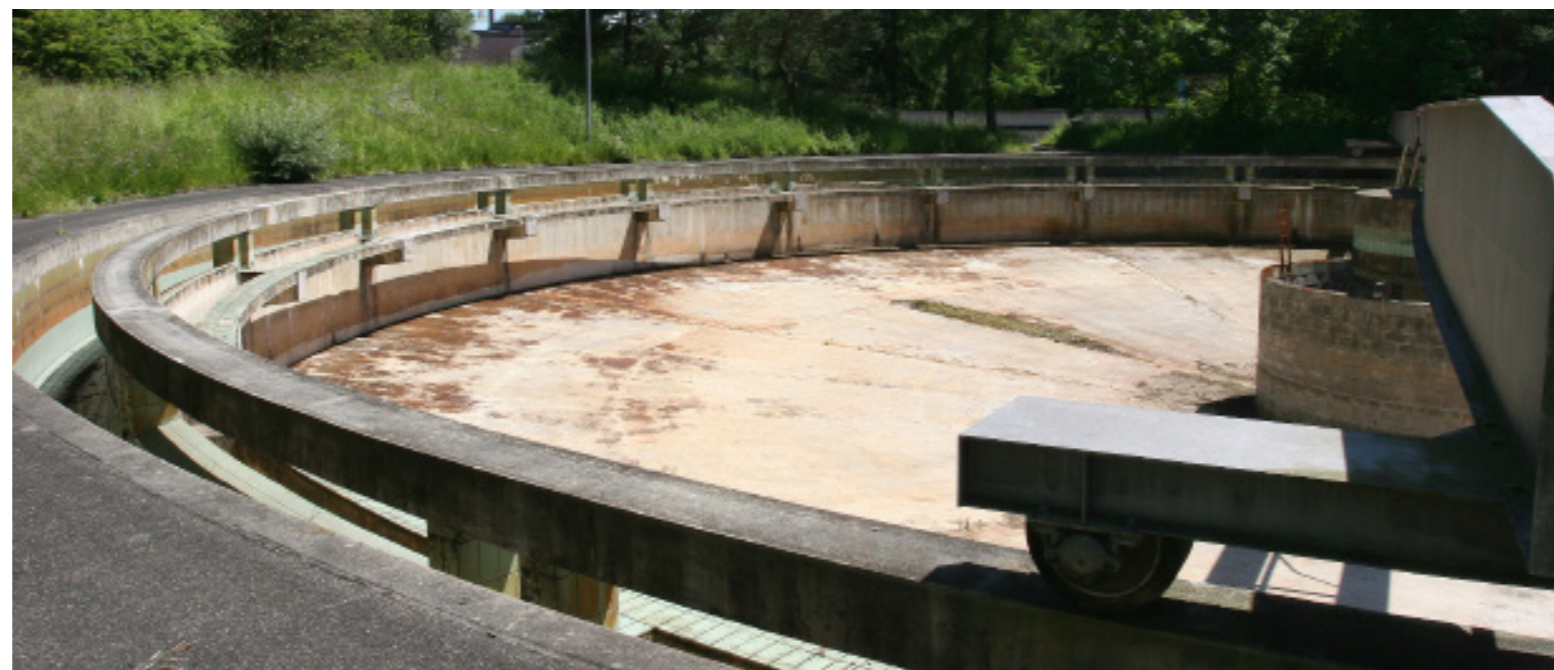
TYPICAL DETAIL

- 1 Concrete wall of clarifier
- 2 Ground level
- 3 Water level within the clarifier
- 4 V2A Stainless steel plate
- 5 Priming of concrete surface with Primer such as Sika® Icosit® KC 330 Primer or equivalent
- 6 Shock absorbing, vibration damping & bonding material such as Sika® Icosit® KC 330 FK
- 7 Priming after grinding the under side of the stainless steel plate with primer such as Sika® Icosit® KC Primer or equivalent
- 8 Scraper bridge

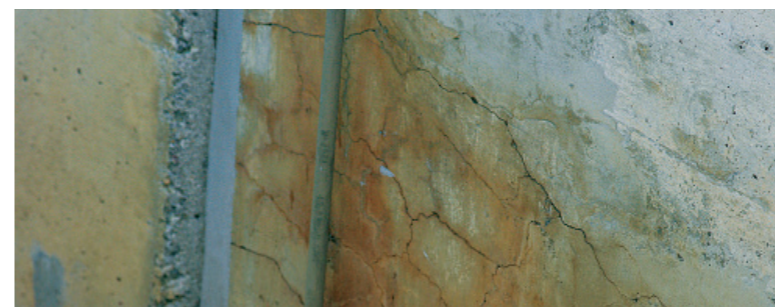
TYPICAL DETAIL

- 1 Host sound concrete
- 2 Cutting line of damaged concrete, cleaned and prepared substrate
- 3 Bonding primer (if relevant/required: e.g. SikaTop® Armatec®-110 EpoCem®)
- 4 Corrosion protective coat (e.g. SikaTop® Armatec®-110 EpoCem®)
- 5 Repair mortar (e.g. Sika MonoTop®-412 NFG)
- 6 Smoothing coat (e.g. Sika MonoTop®-723 N)

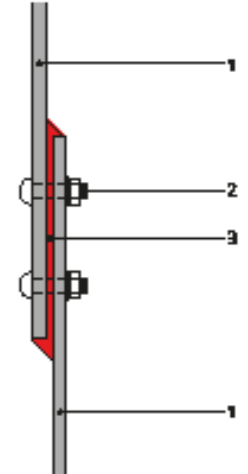
TYPICAL DETAIL

- 1 Steel plates
- 2 Bolt with protection
- 3 Sikaflex® TS Plus

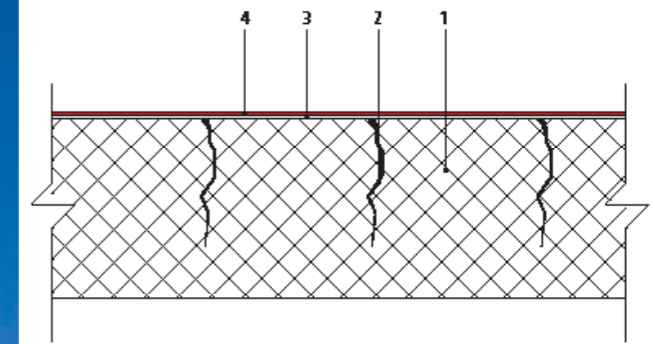
- 1 Concrete
- 2 Cracks
- 3 Primer Sikafloor®-156/-161 lightly broadcasted with quartz sand 0.3 - 0.8 mm
- 4 1 x Sikalastic®-844 XT

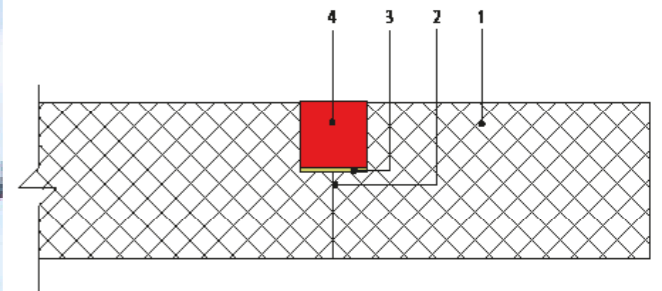
TYPICAL DETAIL

- 1 Substrate
- 2 Construction joint
- 3 Bond breaking
- 4 Sikaflex® Pro-3

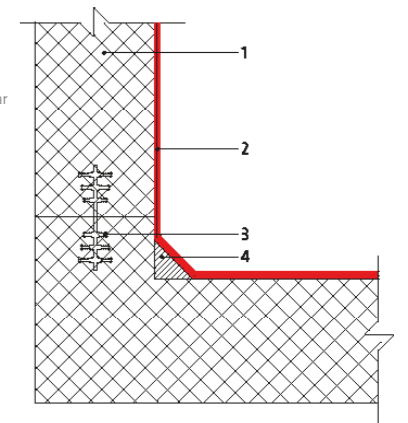
TYPICAL DETAIL

- 1 Concrete substrate
- 2 Sikagard®-720 EpoCem®
- 3 Construction joint Sika® Waterbar
- 4 Sika MonoTop®-412 N

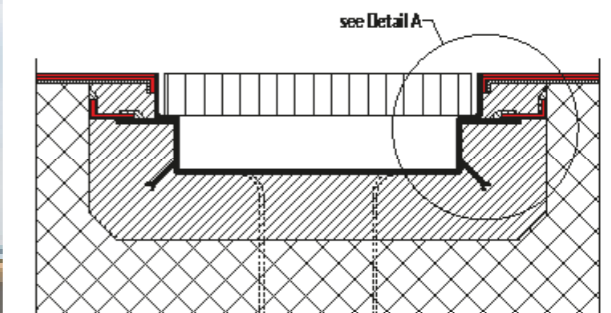
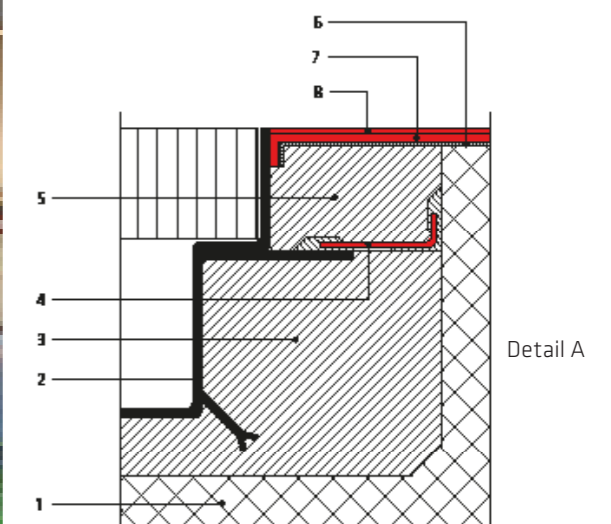
TYPICAL DETAIL

Sikafloor® coating
Connection on drainage channel or outlet

- 1 Concrete slab
- 2 Drainage channel or outlet with adhesive steel flange
- 3 SikaGrout® anchorage mortar
- 4 Sealing adhesive steel flange with Sikadur-Combiflex® SG System
- 5 SikaGrout® anchorage mortar
- 6 Sikafloor® primer (epoxy) thickness ca. 0.1 mm
- 7 Sikafloor® coating in epoxy or PUR thickness ca. 2.0 - 4.0 mm
- 8 Sikafloor® finishing thickness ca. 0.1 - 0.4 mm according to the selected coating system and the mechanical load anticipated in service

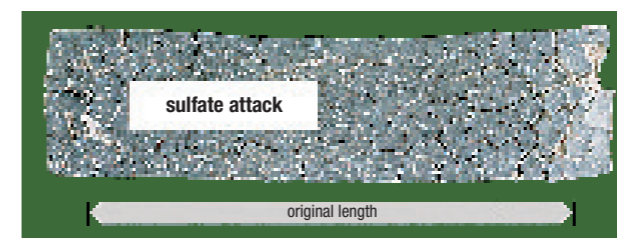
Sulfate driven attack is primarily caused by sulfates dissolved in water. By reacting with the hardened cement matrix, an increase in volume is induced, which damages the structure. (Picture: BetonSuisse, Merkblatt 01)

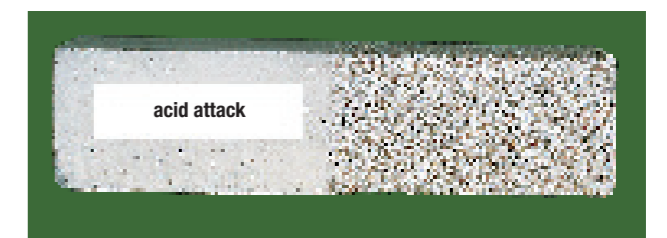
Acidic attacks which dissolve calcium compounds out of the hardened cement matrix can be caused by acids, exchangeable salts, vegetable and animal fats or oils. Degradation of the concrete usually occurs very slowly. (Picture: BetonSuisse, Merkblatt 01)

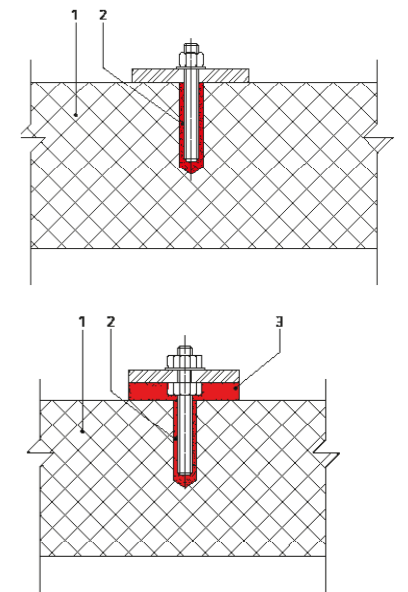
TYPICAL DETAIL

- 1 Concrete substrate
- 2 Sika® AnchorFix-1, 2 or 3
- 3 Leveling mortar Sikadur®-41

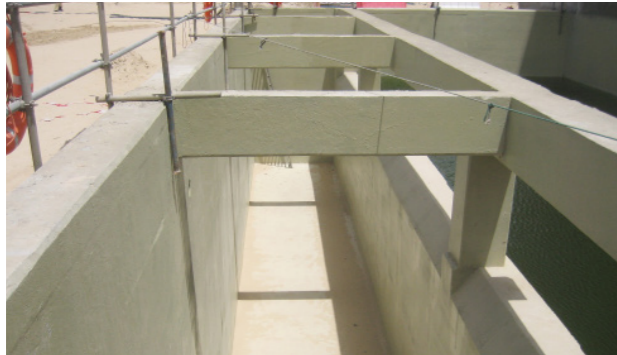
SEWAGE TREATMENT PLANTS AL WATHBA AND AL SAAD, ABU DHABI

The ADWEA sewage project consists of two newly built sewage treatment plants in Abu Dhabi (Al Wathba and Al Saad plant). These two main sewage plants receive approx. 95% of the sewage from Abu Dhabi and Al Ain. The sewage is delivered from substations all around the area.

Main requirements are the chemical resistance to sewage, crack bridging properties, mechanical resistance, waterproofing, suitable floorings, also electrically conductive floors and long lasting joint sealing materials. 36 Sika products have been approved for use in the project.

The floor of the electric rooms was protected with Sikafloor®-262 AS.

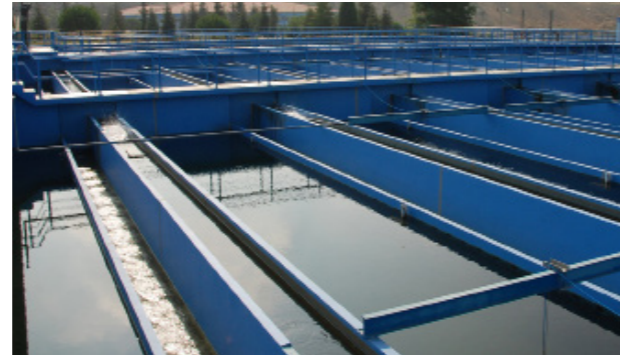
İSKI İKITELLI WASTE WATER TREATMENT PLANT, ISTANBUL, TURKEY

This is a large sewage water treatment plant with capacity to provide water to 5'200'000 people, 40% of the population in Istanbul. It has 2 separate water treatment systems, which provide 840.000 m³ of clean water a day. System 1 was completed in 1998 and system 2 in 2003.

The sewage treatment plant treats waste water containing the biological contamination and eutrophication. It needs to use various procedures and chemicals to make the water finally clean before going back to the city's water supply system. The water containing structures have to survive under extremely severe conditions and resist against microbiological and chemical attack.

Concrete spillings were repaired using Sika MonoTop® polymer modified patch repair mortar.

Concrete was protected against chemical aggression with first a primary application of Sikagard®-720 EpoCem as temporary moisture barrier, followed by Sikagard®-2040 TR chemical resistant epoxy coating.

Jointing of concrete elements was done with the chemical resistant sealant Sikaflex® Pro 3.

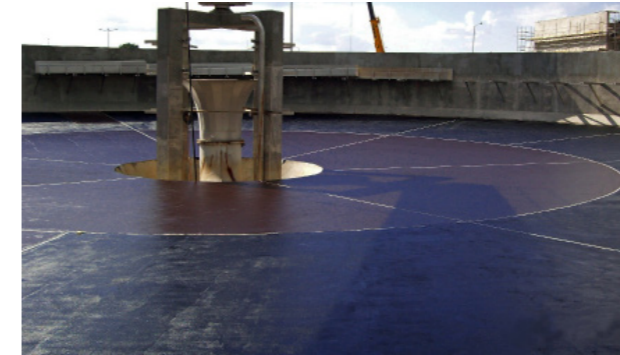
WROCŁAW WASTE WATER TREATMENT PLANT, POLAND

The sewage treatment plant in Wrocław is a mechanical-biological sewage treatment plant with chemical-assisted removal of phosphorus and full sludge processing. The goal of the third phase of development and modernization of the sewage treatment plant was to increase the capacity from an average of 70 000 to 140 000 m³ per day, and to fulfill more stringent standards of water leaving the plant and entering the river stream.

Sika® Repair-30 F - repair mortar and Sika® Poxitar F - epoxy coating (3 layers)

Sika® Repair-30 F - as levelling mortar and Sika® Poxitar F - epoxy coating (3 layers)

Sika® Repair-30 F - as levelling mortar and Sika® Poxitar F - epoxy coating (3 layers - laminated)

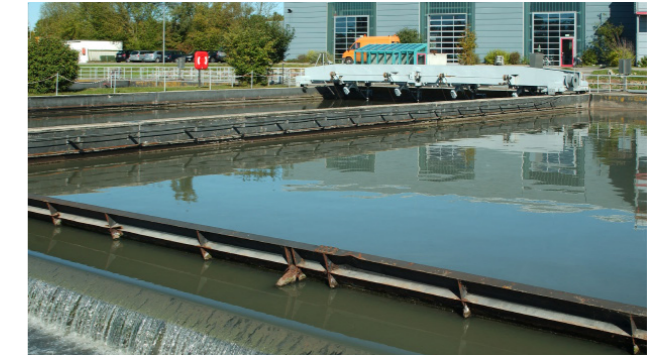
SINDELFINGEN-BÖBLINGEN WASTE WATER TREATMENT PLANT, GERMANY

This plant belongs to the community towns of Sindelfingen and Böblingen. This WWTP alone treats over 15 million cubic meter of waste water annually. The plant boasts efficient treatment of the waste water. For organic pollutants a purification rate of over 90% is achieved and at the same time more than 70% of dissolved nutrients including phosphorus and nitrates are removed from the water.

The two primary settlement tanks and the mechanical scrapper tracks were in need of immediate refurbishment. Concrete under the settlement tanks was suffering from decays. The mechanical scrapper tracks were subjected to heavy abrasion. Exposed steel structures were corroding.

Sika MonoTop®-602 / 603 Neu - Polymer modifier repair mortar

Sika® Elastomastic® TF - wear resistant, crack bridging polyurethane epoxy resin
